# D8.1 - Energy audits and surveys I

Version	1.0
Grant Agreement Number	101079957
Project Acronym	RE-SKIN
Project Title	Renewable and Environmental-Sustainable Kit for building Integration
Project Call	HORIZON-CL5-2021-D4-02-02
Project Duration	42
Deliverable Number	D8.1
Contractual Delivery Date	31/05/2023
Actual Delivery Date	14/11/2023
Deliverable Title	Energy audits and surveys I
Deliverable Type	R
Deliverable Dissemination Level	PU
Work Package	8
Lead Partner	ZH
Authors	A. Miglioli, L. Maestri
Contributing Partners	POLIMI
Reviewers	C. Del Pero, F. Leonforte

Location: Milan, Italy - Via Amantea No.5 Owner: Municipality of Milan (CDM) Destination: Community house Climate: Continental climate Year of construction/retrofit: 1965/2005

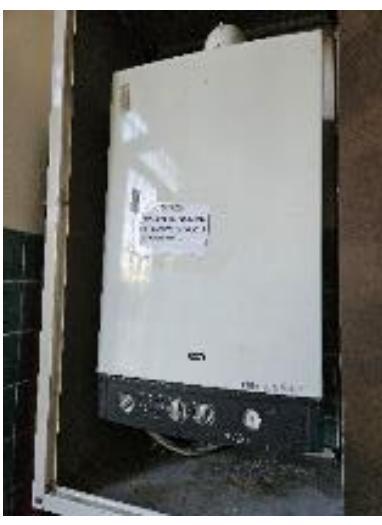
Figure 25. Ground Floor boiler

The first one, installed in a dedicated cabinet in the laundry room on the ground floor, is a traditional wall-mounted boiler with a nominal thermal power of approximately 31 kW and, as mentioned, is exclusively used for the ground floor. It is responsible for managing the heating loads of the ground floor and ensuring the production of domestic hot water for the two sinks in the bathrooms, the kitchen and the laundry.

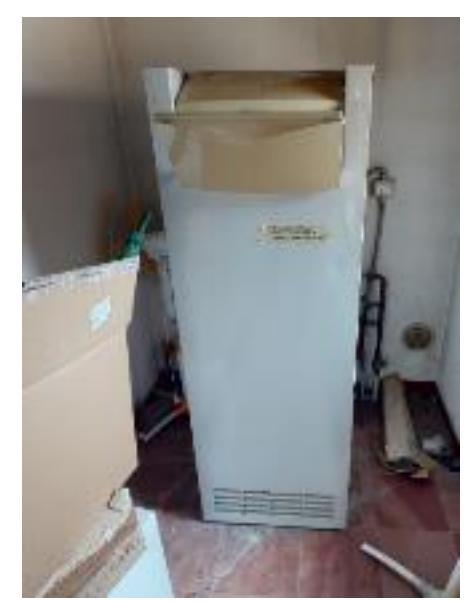
Figure 26. Floor-standing boiler located at the first floor

On the other hand, the first floor is served by a second boiler, located in a dedicated technical room at the top of the stairs. This is a floor-standing boiler and it is equipped with a domestic hot water storage tank of about 200 I. It exclusively serves the first floor and, compared to the previous one, the production of hot water required by this boiler is higher, as it must serve not only the bathroom sinks but also the six showers, of which, only five are functioning and usable.

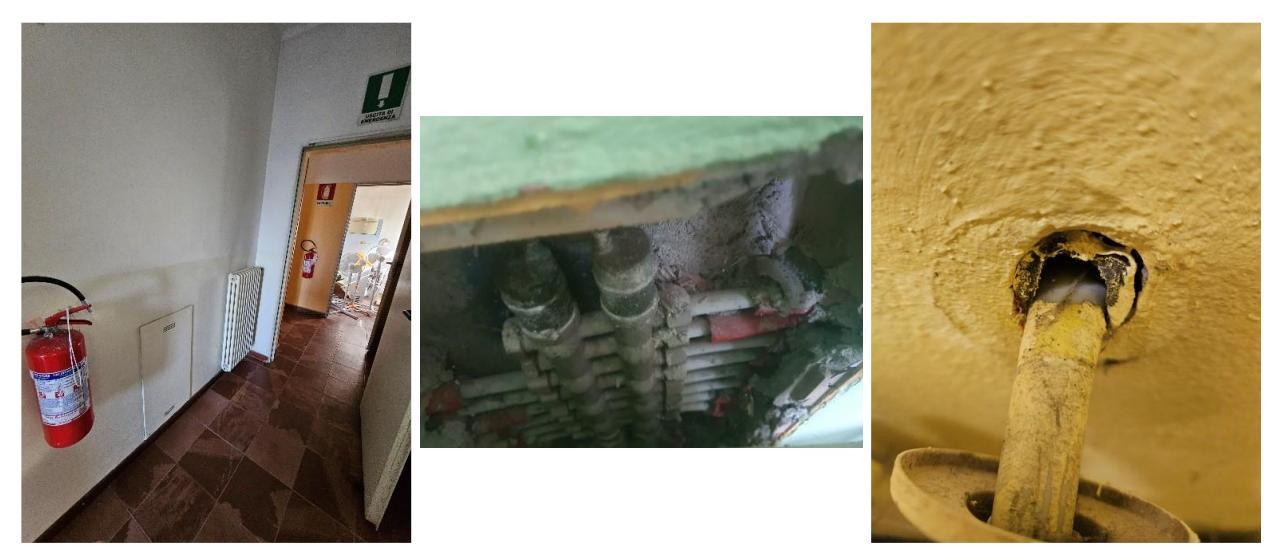
Figure 27. Example of radiator, collector, and type of piping

The collectors, recessed into the wall behind flush-mounted doors, are traditional brass collectors installed vertically without any pipeline interception. Each collector serves a group of radiators on the floor, with each radiator being supplied by two pipes: one for supply and one for return, both with an outer diameter of approximately 15 mm. The pipes used for the distribution of the heat transfer fluid (water) to individual radiators, as shown in the photo, are made of multilayer PE-X material with insulating sheathing and are most likely in compliance with the current regulations in Italy.

It's worth considering that, as is the case for most of these types of systems, the setpoint temperature for the heat transfer fluid (water) used for heating hovers is around 65°C. No thermostatic valves have been detected on any radiators to control the flow, based on room temperature, into each terminal for consumption management.

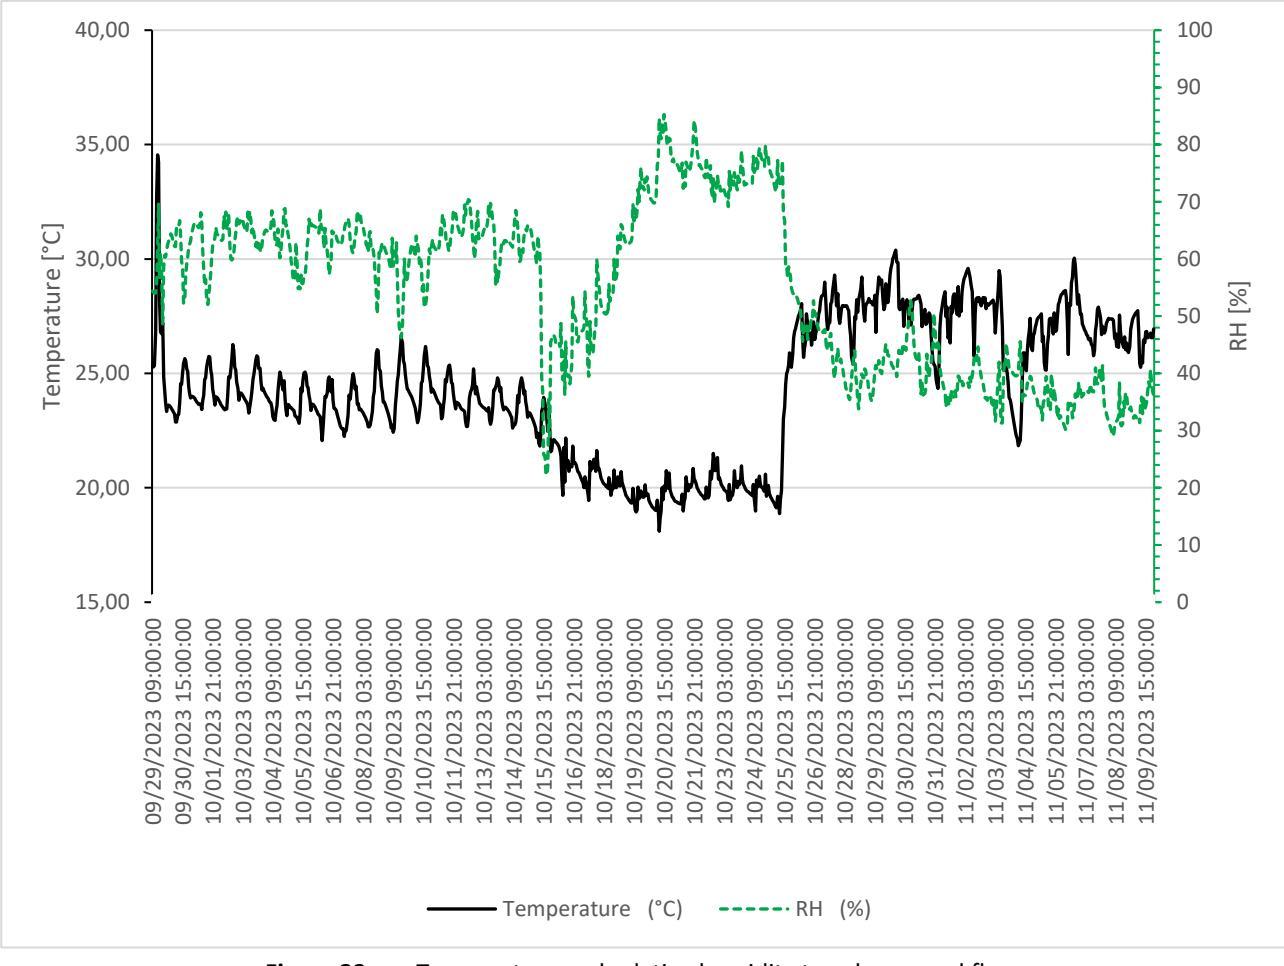
Figure 33. Temperature and relative humidity trend – ground floor

Temperatures in the rooms vary on average from 21°C to 26 °C until the mid of October, after that the temperature tend to drop until around 19°C. Starting from the 25<sup>th</sup> of October, the internal temperature raised again, due to the start of the heating system, and at the ground floor achieved temperatures up to 30°C. In such respect, it is possible to deduce that the control system is not able to set the proper temperature/flow rate of the working fluid.

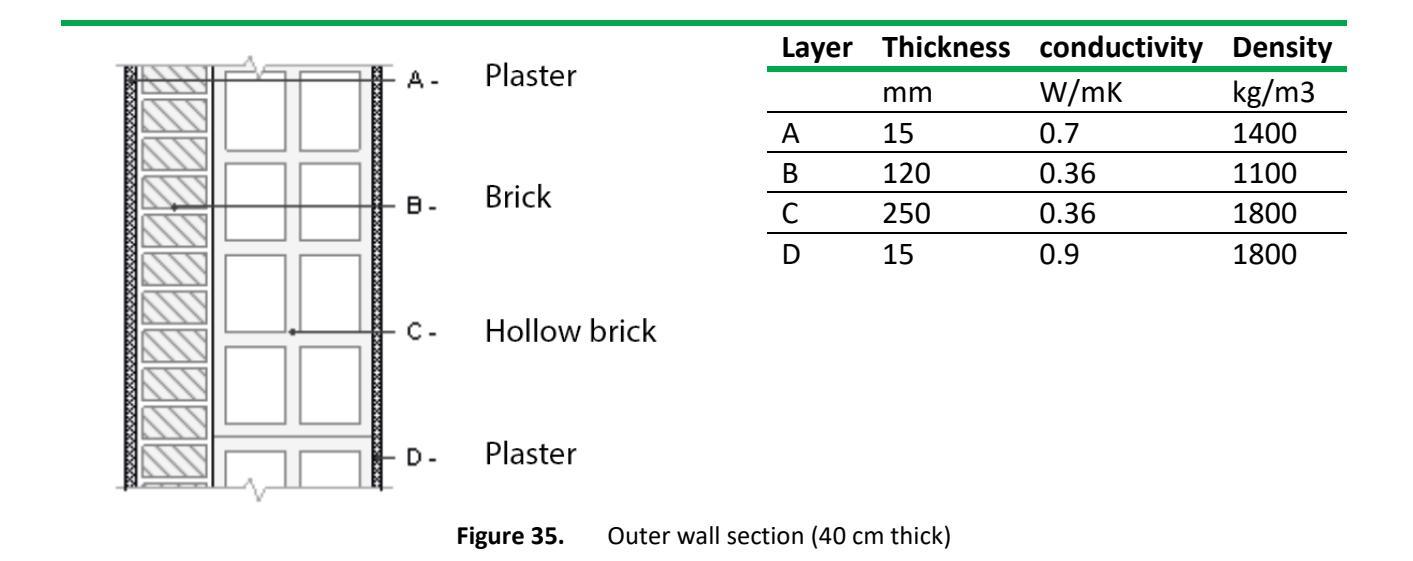
Hereafter, the thermo-physical proprieties of the main opaque envelope is described. The typology of structures has been retrieved according to the construction year in combination with a visual survey of the stratigraphy of the wall in correspondence of the ventilation hole of the kitchen. On average the exterior wall, 40 cm thick, is characterized by two rows of bricks, one solid and one hallowed, covered with plaster on both sides, for a total thickness, U value and the superficial mass equal to 40 cm, 0.816 W/m<sup>2</sup>K and 580 kg/m<sup>2</sup>, respectively.

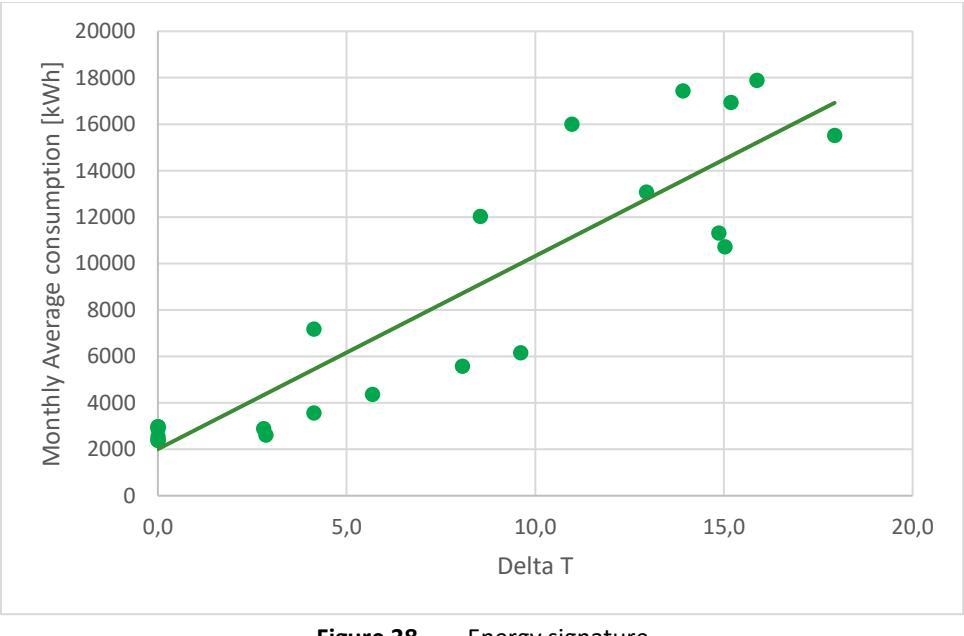
Figure 38. Energy signature

• a slight deviation from the trend line in several points is shown. This is typically caused by the low accuracy of the control system, which is not able to follow the outdoor air temperature trend;

- the intercept with 0 kWh is higher than 20°C of outdoor air temperature. It means that the building is characterized by high internal gains and the control logic is not so accurate;
- Regression line's slope suggests that the building is characterized by an average heat transfer coefficient of around 1.18 kW/K.
